# *LDS Inspections*

## **Home Inspection Report For**

*1234 Any Street  
Your Town, PA 11111*

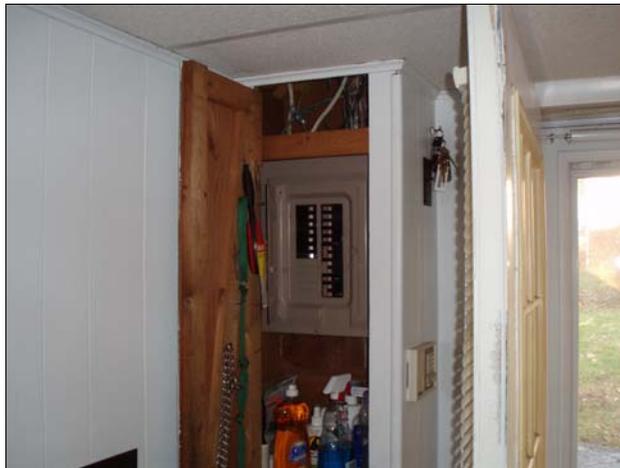
***ATTENTION:*** There is insufficient clearance around the service entrance panel. It has been a rule for decades that service entrance panels must be readily accessible, so they can be reached easily and safely. That means a working space in front of the panel at least 30 inches wide by 36 inches deep from the floor to a height of 6ft. 6 inches, and one must be able to open the cover to an angle of at least 90°. This panel may have been this way for years or even since the home was new, but that doesn't change the fact that this configuration is incorrect and potentially unsafe. I recommend having this corrected by a licensed electrician.

***IMPORTANT:*** The electrical service panel does not have the required 3-foot clearance at the front and both sides of the panel as required.

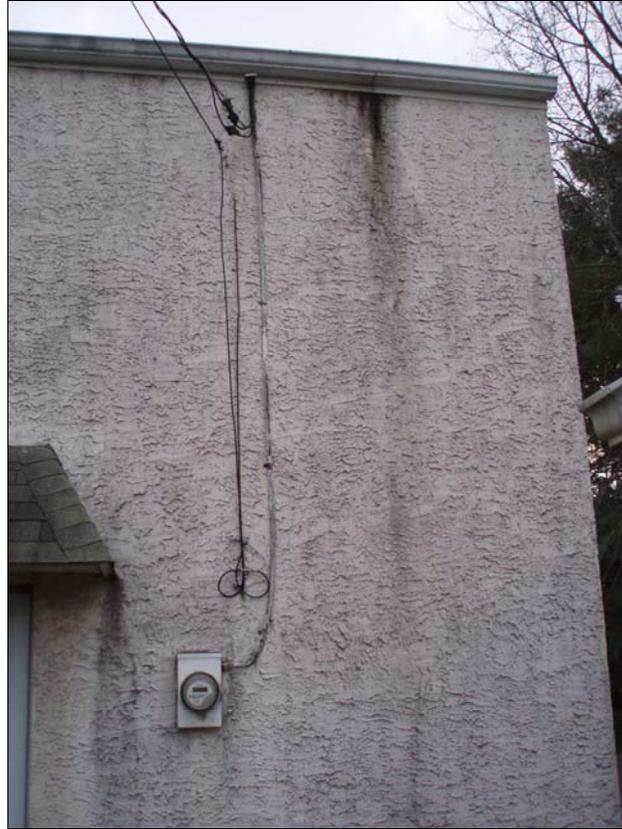
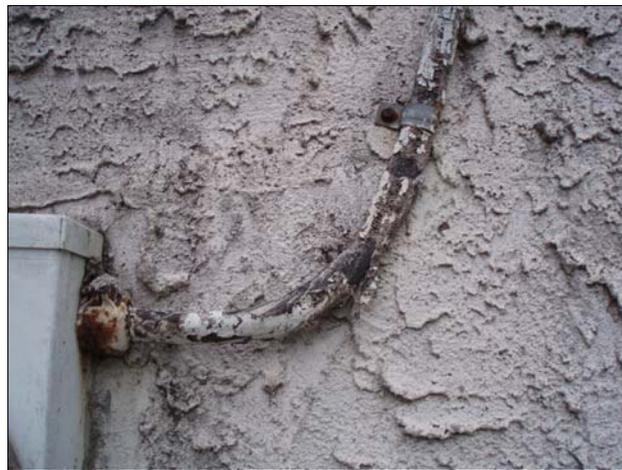
***IMPORTANT:*** The existing electrical service is showing signs of age. The insulation that protects the wiring is deteriorating and the mast head doesn't meet current standards for weather protection. While it may not be necessary to have this replaced, a certified electrician should be asked to review this area and recommend a course of action.

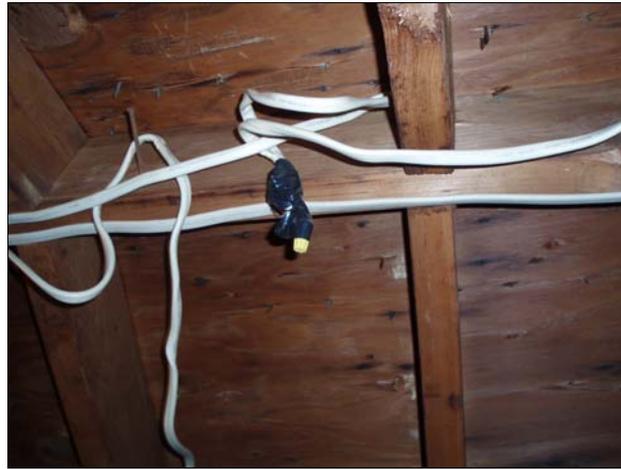
**REPAIR NEEDED:** There are electrical wires in the attic that have been spliced and not contained in approved junction boxes. Recommendation: Have all splices installed inside required junction boxes by a licensed electrical contractor.

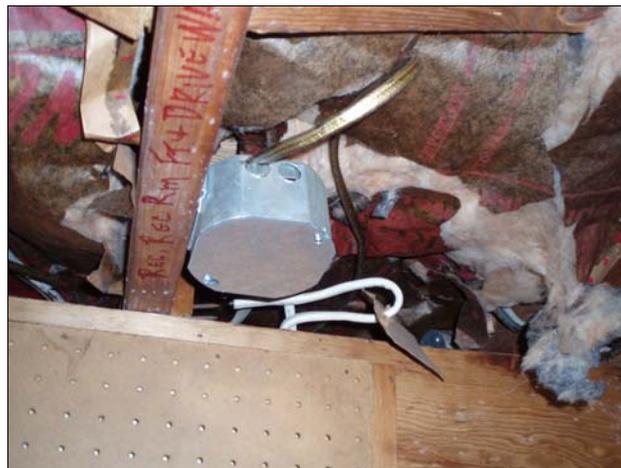
**REPAIR NEEDED:** Romex wiring exiting a junction box in the basement closet, adjacent to the laundry room, is missing a wire clamp. Wire clamps are necessary in order to prevent the wire from being cut by the edges of the metal junction box. It is recommended that a certified electrician install the proper wire clamps.

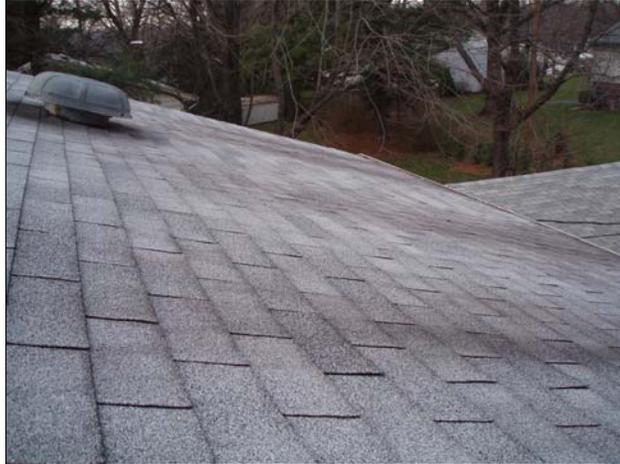
***REPAIR NEEDED:*** Early indications of surface failure, such as erosion of the protective granular coating, raised ridges and cracked, brittle or missing shingles were evident at the time of inspection. Consulting a professional roofer now to have immediately necessary repairs made, and to discuss cover replacement options, costs and timetable is recommended.

**REPAIR NEEDED:** Early indications of surface failure, such as erosion of the protective granular coating, raised ridges and cracked, brittle or missing shingles were evident at the time of inspection. Consulting a professional roofer now to have immediately necessary repairs made, and to discuss cover replacement options, costs and timetable is recommended.

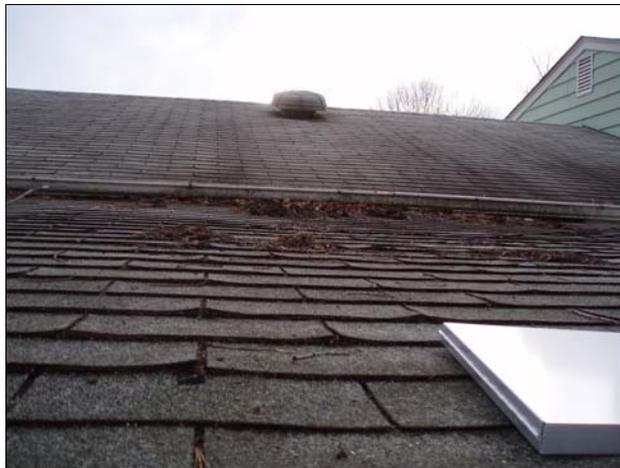
***REPAIR NEEDED:*** The asphalt shingle roof of the rear porch is in worse condition than the main house roof. This is due in part to the very low slope of this roof and due to the rain gutters being clogged with debris. It is highly recommended that this roof be replaced and the gutters cleaned of all debris.

**REPAIR NEEDED:** The asphalt shingle roof of the rear porch is in worse condition than the main house roof. This is due in part to the very low slope of this roof and due to the rain gutters being clogged with debris. It is highly recommended that this roof be replaced and the gutters cleaned of all debris.

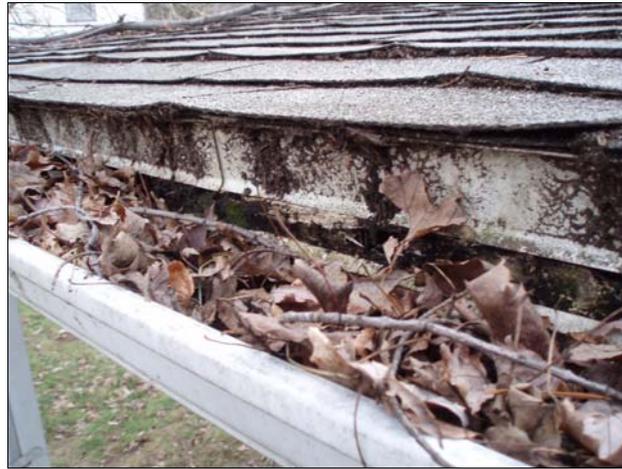
***REPAIR NEEDED:*** Rot is evident along the fascia of the rear porch roof above the gutters. It is recommended that this area be repaired by a competent carpenter. It is also recommended that the gutters be cleaned of all debris to prevent this from happening again.

**REPAIR NEEDED:** Rot is evident along the fascia of the rear porch roof above the gutters. It is recommended that this area be repaired by a competent carpenter. It is also recommended that the gutters be cleaned of all debris to prevent this from happening again.

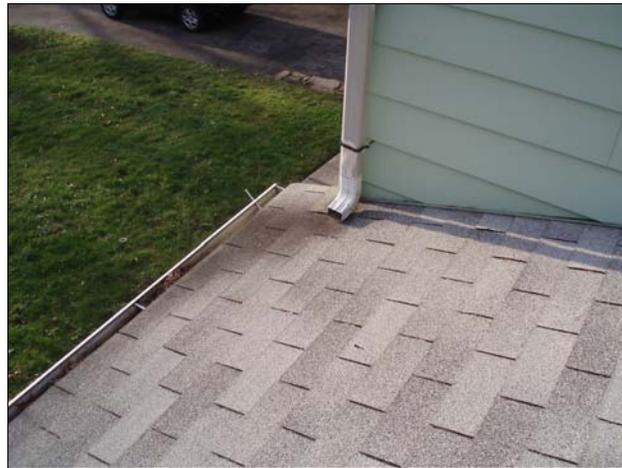
***REPAIR NEEDED:*** The gutters need to be reattached at one or more locations. Gutters often become detached after they are clogged and fill with water, ice or snow. Having the pitch of all gutters checked and the loose gutters reattached at the proper pitch is recommended. Thereafter, the gutters should be cleaned and the attachment points checked at least twice a year as part of routine maintenance.

**REPAIR NEEDED:** The gutters need to be reattached at one or more locations. Gutters often become detached after they are clogged and fill with water, ice or snow. Having the pitch of all gutters checked and the loose gutters reattached at the proper pitch is recommended. Thereafter, the gutters should be cleaned and the attachment points checked at least twice a year as part of routine maintenance.

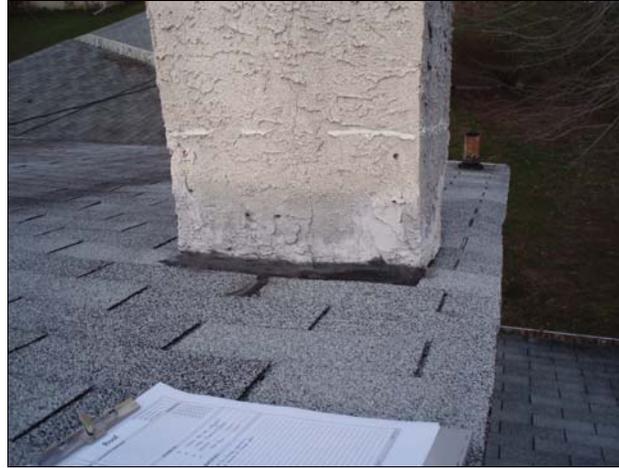
**REPAIR NEEDED:** There does not appear to be any flashing around the chimney structure and the stucco covering extends all the way to the roof surface. It is recommended that a certified roofing contractor install aluminum flashing at the base of the chimney to prevent water infiltration and structural damage to the chimney.

**REPAIR NEEDED:** There does not appear to be any flashing around the chimney structure and the stucco covering extends all the way to the roof surface. It is recommended that a certified roofing

contractor install aluminum flashing at the base of the chimney to prevent water infiltration and structural damage to the chimney.

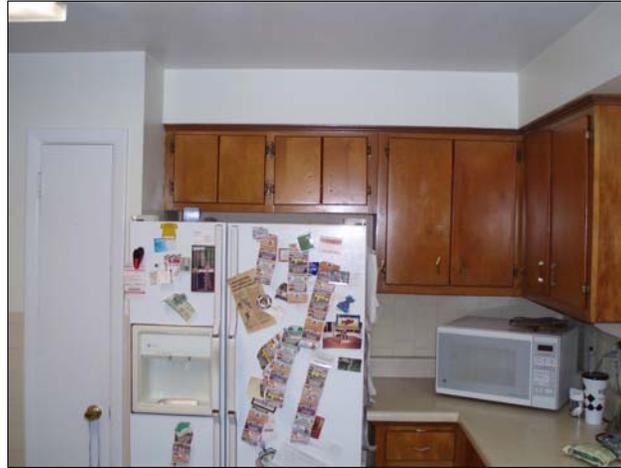
**REPAIR NEEDED:** Several of the kitchen cabinets are missing door hardware.

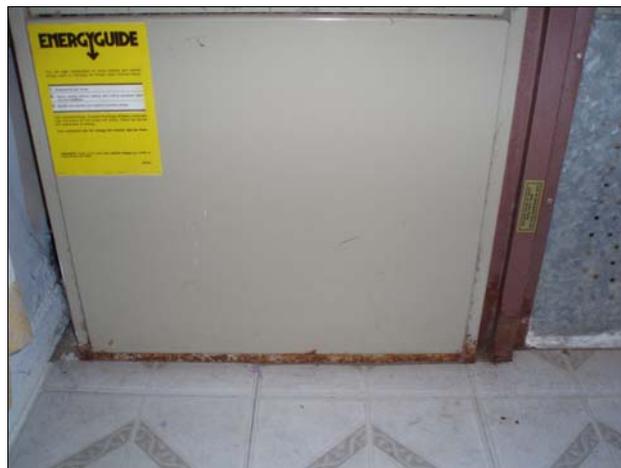
**REPAIR NEEDED:** The furnace/boiler housing is rusted. This usually indicates exhaust condensate leakage, a backdrafting flue or, in the case of a hot water/steam system, may indicate a boiler leak. I recommend having this unit immediately inspected and repaired as necessary by a reputable/professional HVAC firm.

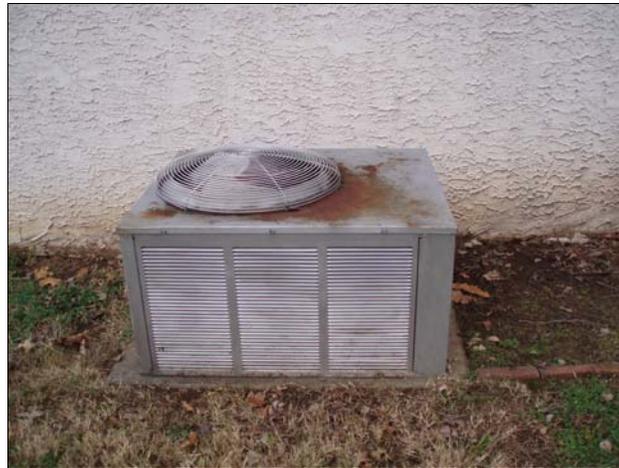
**ATTENTION:** Deteriorated housing side panels, water trays, exterior housing and/or frame were noted on the evaporative cooler.

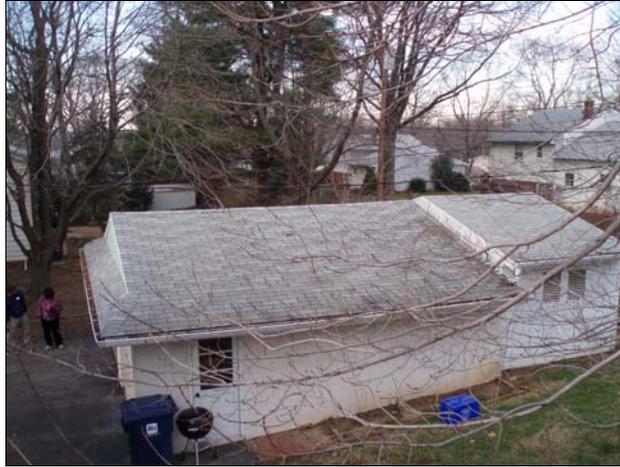
***REPAIR NEEDED:*** Although no signs of water infiltration could be seen at the time of inspection, the asphalt shingle roof has reached its life expectancy and should be replaced.

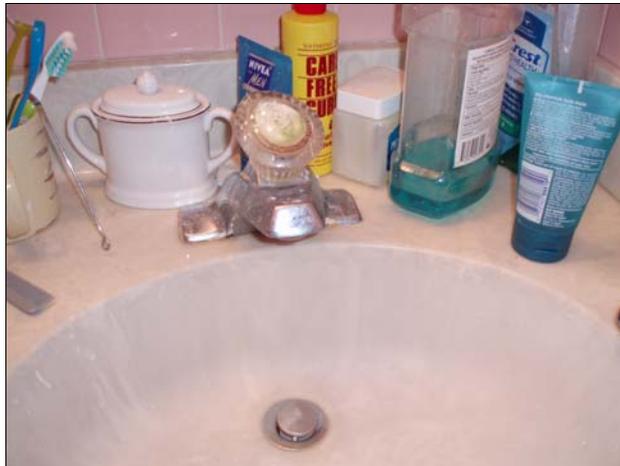
***REPAIR NEEDED:*** The faucet set located at the right side of the main bathroom's vanity is heavily corroded and rusted. It is recommended that this be replaced to prevent possible failure.

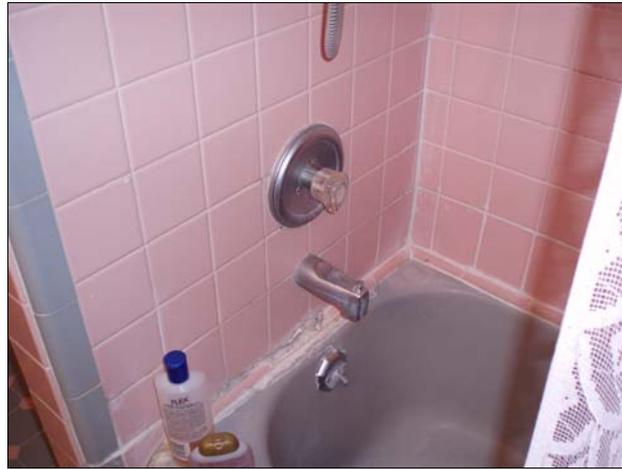
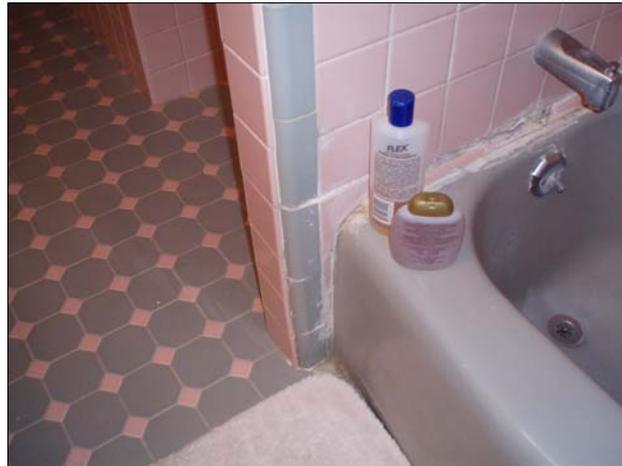
***REPAIR NEEDED:*** The ceramic tile tub surround in the main bathroom is in poor condition and several tiles are loose and excessively caulked. It is recommended that the loose tile be removed and the tub surround be repaired by a certified contractor.

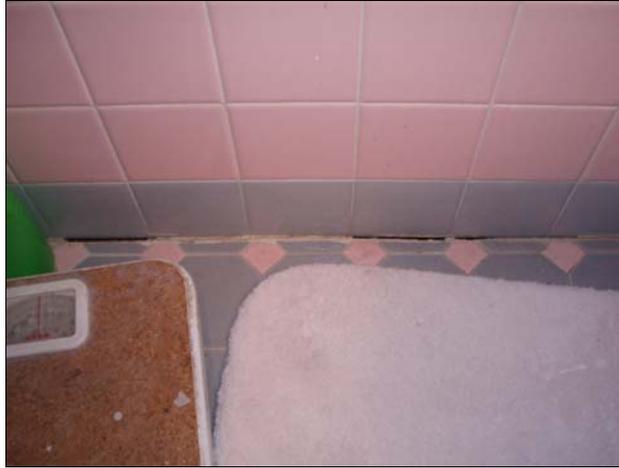
**REPAIR NEEDED:** The ceramic tile floor is missing grout in several locations in the main bathroom. This can allow for water to infiltrate into the floor assembly and possibly damage the structure of the building. It is recommended that tiles be grouted solid to prevent any potential damage.

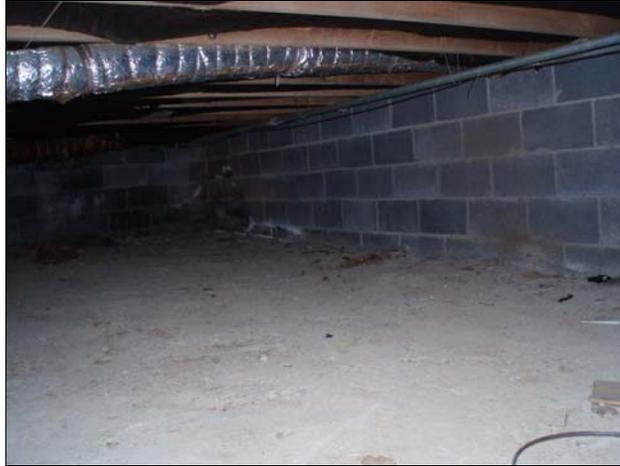
Efflorescence or other clues to moisture infiltration seen at the basement walls indicates a lack of adequate damp proofing at the exterior of the foundation. This will raise ambient moisture levels in the basement and could result in excessively humid conditions, leading to formation of mold or conditions conducive to wood-destroying organisms. Some measures should be taken to either reduce humidity or reduce the amount of moisture passing through these basement walls. There are heavy coating products that can be applied to the inside surfaces of the foundation to block water movement, interior drainage systems can be installed and/or dehumidifiers can be used. Consultation with a reputable drainage/dampproofing contractor to discuss options and related cost is recommended.

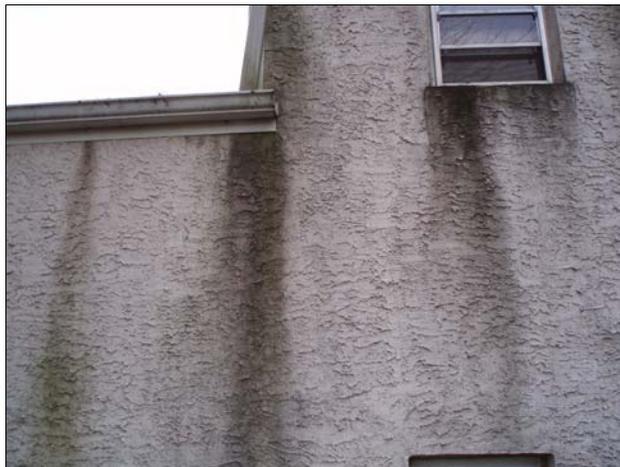
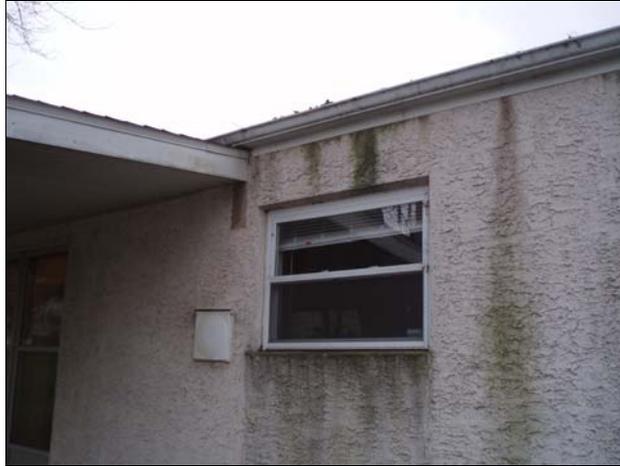
**ATTENTION:** The stucco cladding is stained as a result of the gutters overflowing. If cleaning doesn't remove the stains, it may be necessary to paint the affected area. I don't recommend that the client attempt to do this as a do-it-yourselfer project, since only paint specifically formulated for stucco should be used for this purpose. Consult a reputable stucco contractor to discuss options and cost.

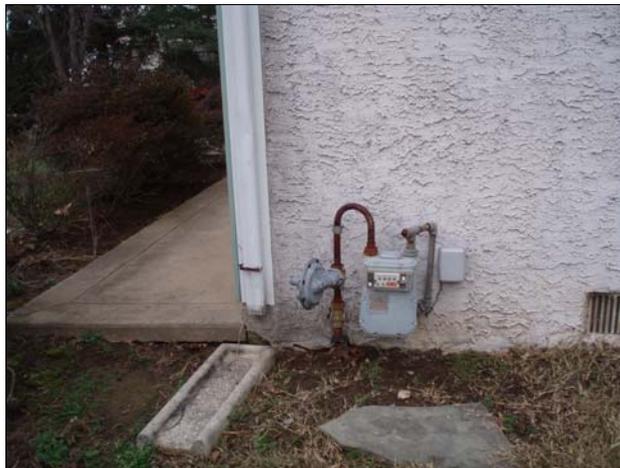
***IMPORTANT:*** The stucco cladding is in contact with grade or flatwork or there is insufficient clearance below the wall terminations. Stucco is designed to allow rainwater to drain down the back of the cladding and leave the wall via weep screeds at the bottom. There needs to be at least two inches of clearance between the bottom edge of the stucco and any flatwork, such as sidewalks, patios and stoops, and no less than four inches above graded soil. Failure to provide adequate clearance by installing the material too close to adjacent surfaces, or installing flatwork against it, can keep the cladding unacceptably wet or trap water in the walls, eventually resulting in rot. Correction requires either lowering flatwork, re-grading the yard or adjusting the point at which the wall cladding terminates. I recommend consulting a reputable stucco contractor to discuss corrective options and cost.

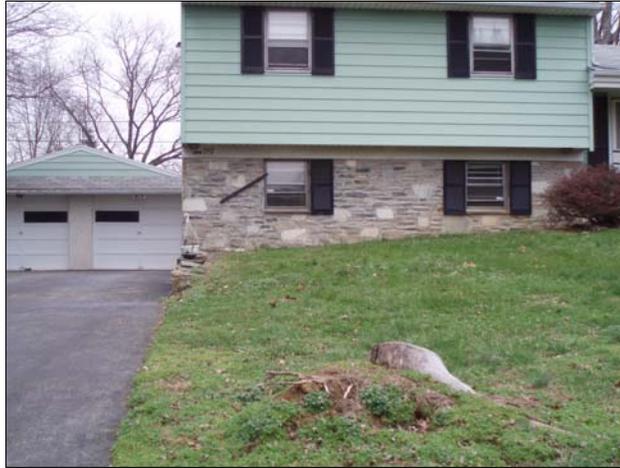
***REPAIR NEEDED:*** A basement window shutter is missing along the front of the house.

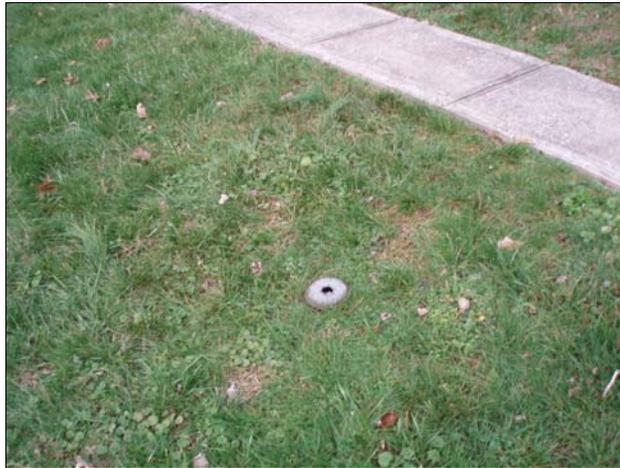
***REPAIR NEEDED:*** A utility pipe in the front yard has a damaged cap. It is recommended that the cap be replaced by the utility company to prevent debris from entering the pipe.

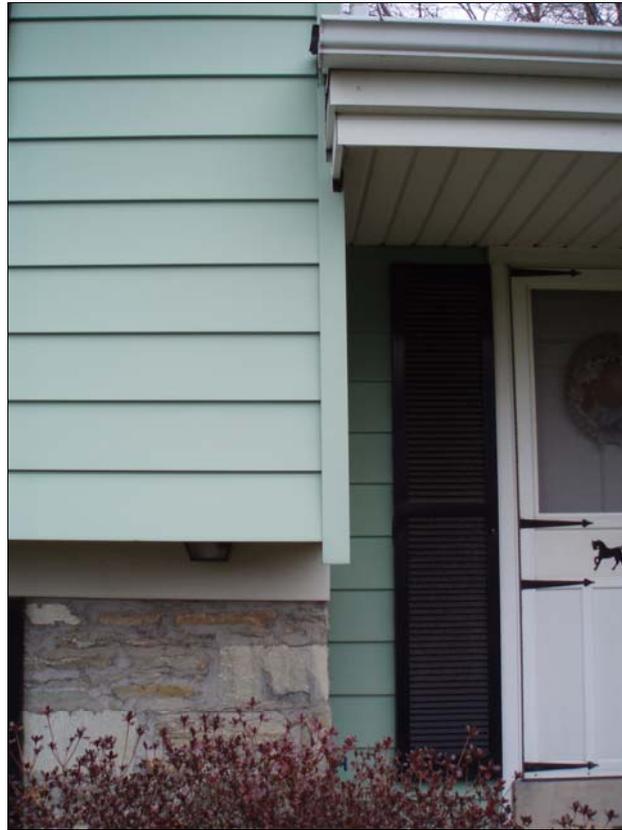
***REPAIR NEEDED:*** A piece of aluminum siding corner trim has slipped down the wall exposing the seam at the front corner of the building near the main entry door. Re-align this piece of trim and secure properly to prevent water infiltration.

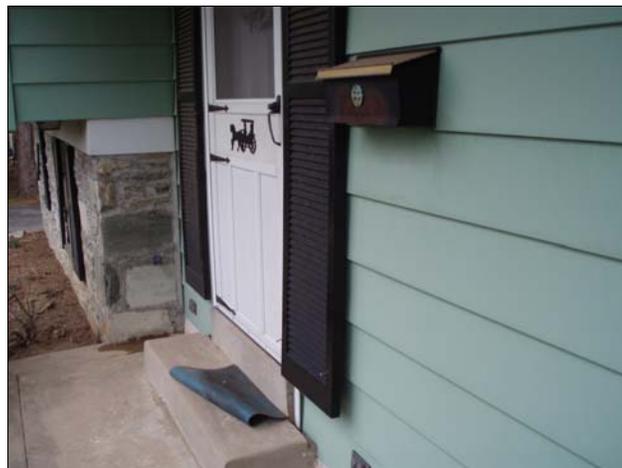
***REPAIR NEEDED:*** The shutter to the right of the main entry door is pulling away from the wall. Properly secure the shutter to the wall and caulk all nail holes to prevent further damage to both the shutter and the aluminum siding.

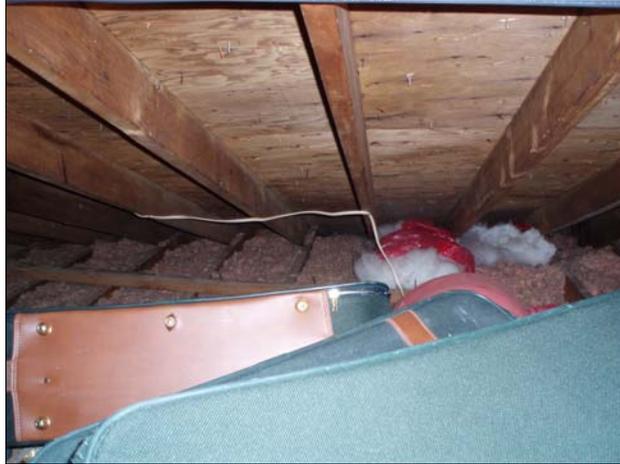
**REPAIR NEEDED:** It was found that the blown-in insulation in the attic above the second floor is in contact with the roof in nearly every other rafter bay between the frieze vents. This is an unsatisfactory condition, as moisture migrating up through the insulation will likely contact the cold underside of the roof, condense and then drip down to the ceilings below. Besides staining the ceilings, this could result in formation of mold in the insulation on top of the ceilings. There should be about 1-1/2 to 2 inches of clearance between the insulation and the underside of the roof to avoid this type of issue. It is recommended that this be brought to the attention of the builder for correction.

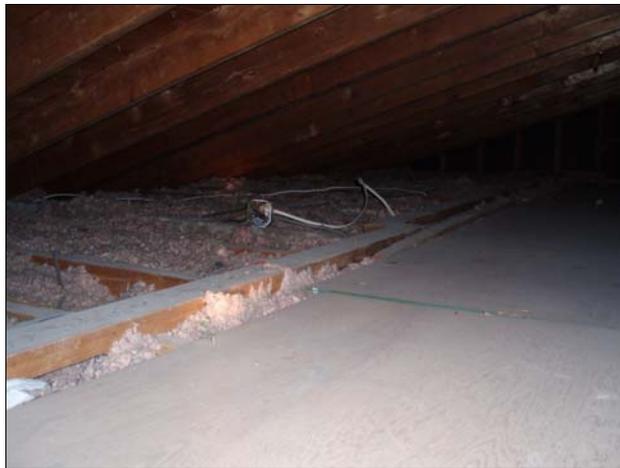
**REPAIR NEEDED:** An electrical junction box is missing its cover within the lower attic. It is recommended that a new cover plate be installed.

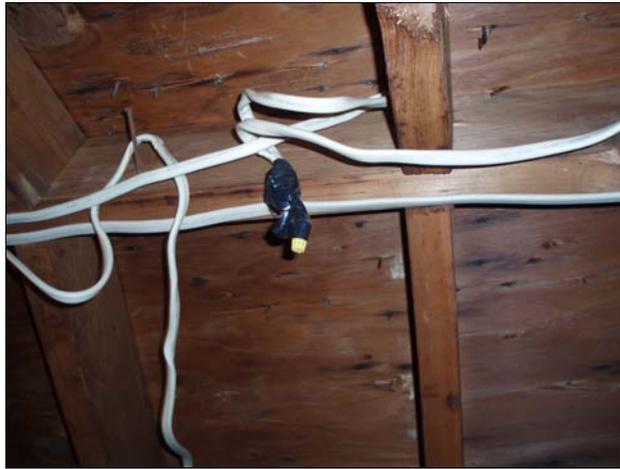
***REPAIR NEEDED:*** There is an electrical wire splice which is not contained in an electrical junction box within the upper attic space. It is recommended that a certified electrician install a proper junction box to eliminate this potential hazard.

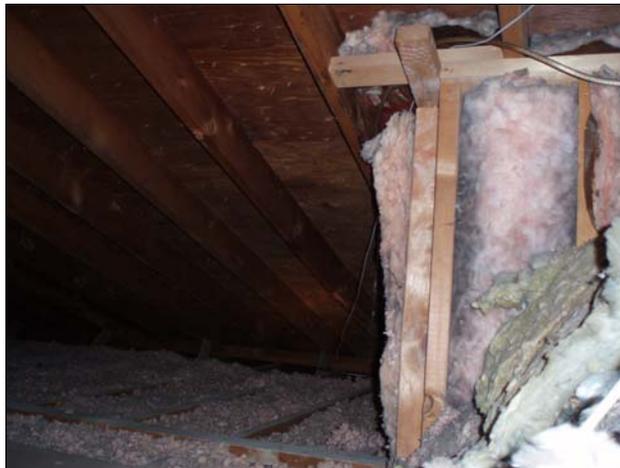
***REPAIR NEEDED:*** A split roof rafter was discovered in the lower attic. It is recommended that the rafter be sistered with a new 2x6 on each side to reinforce it. Only one rafter was discovered to be split, therefore the integrity of the roof structure is still acceptable.

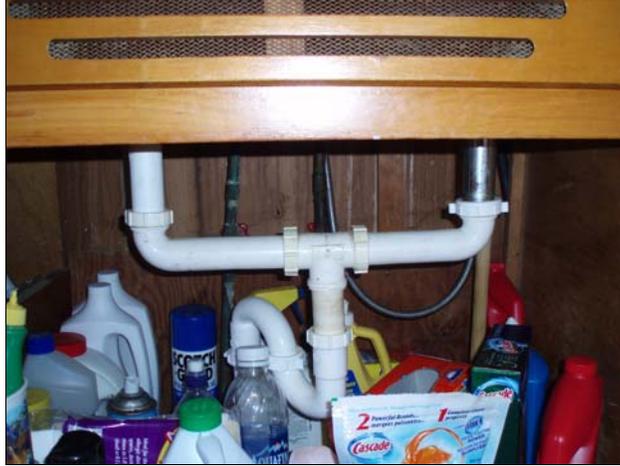
**REPAIR NEEDED:** The drain trap configuration for the kitchen sink is incorrect. Currently the union fitting for the two drains is a reversed slip style connection which does not allow for a tight seal. It is recommended that a certified plumber replace this drain.

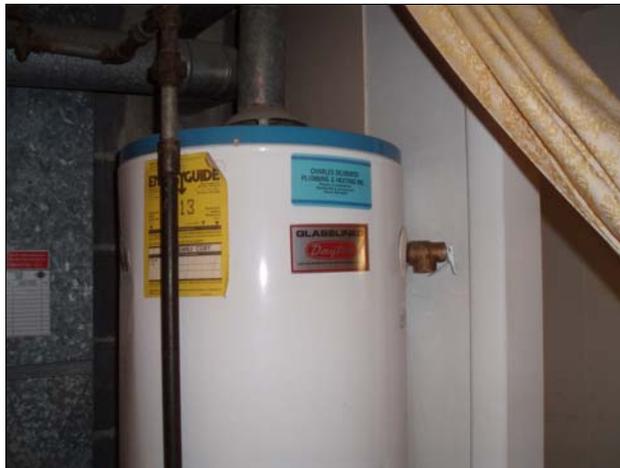
**REPAIR NEEDED:** There is no discharge pipe installed at the temperature pressure relief valve on the water heater. There is supposed to be a discharge pipe installed and configured in a continuous drainage plane that either terminates outside or within 6- inches of the floor. The reason for the discharge pipe is simple - to prevent injury from scalding, should the TPR valve suddenly vent boiling water or water under extreme pressure. Recommendation: Install proper drainpipe consisting of like material as required.

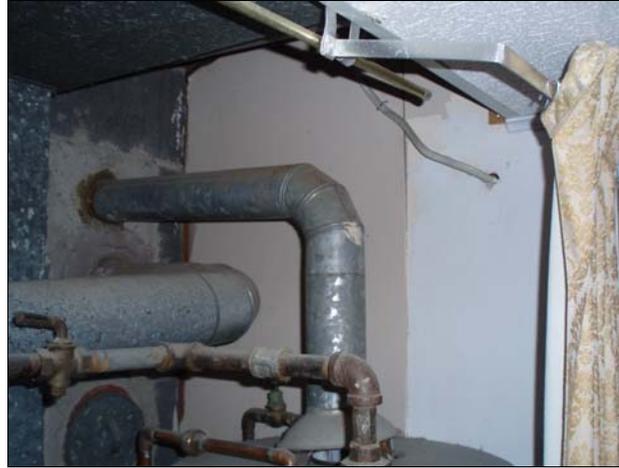
***REPAIR NEEDED:*** Water/moisture infiltration can be seen where the Hot Water Heater flue enters the chimney. This could be the result of water leaking down the chimney or the result of an improperly sized flue. It is recommended that the chimney receive a weather shield and that a certified plumber inspect this area further.

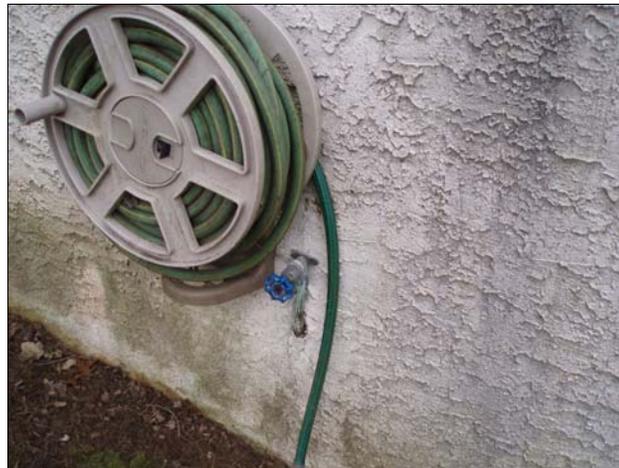
***IMPORTANT:*** Neither hose bib on the exterior of the hose are frost proof. It is recommended that frost proof hose bibs be installed to prevent the pipes from freezing during the winter months.
