LDS Inspections

Home Inspection Report For

*1234 Your Street
Anytown, PA 11111*

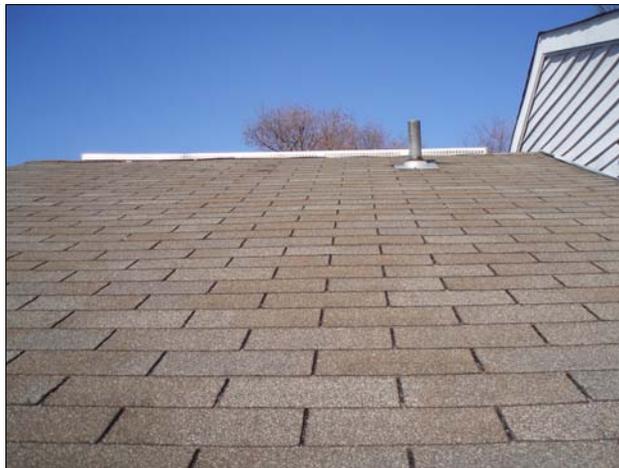
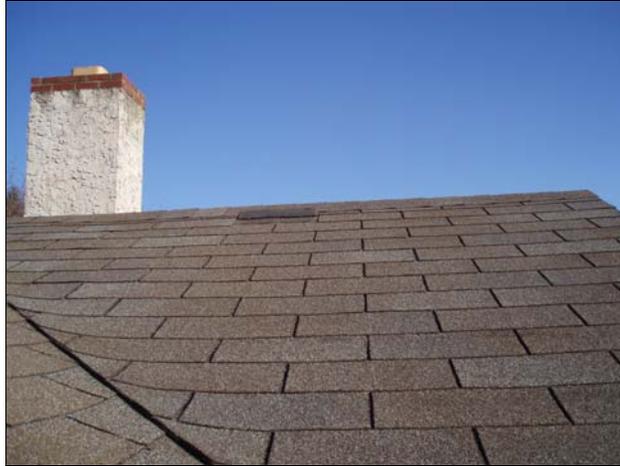
REPAIR NEEDED: Some damaged or missing roof shingles were noted. Immediate repair by a reputable roofing contractor is recommended.

Fishmouthing, the tendency of improperly installed or defective shingles to flex upward displaying a gap like the open mouth of a fish, was seen on this roof. This is an unacceptable condition that will need correction by a professional roofer. It is entirely possible that correction of this condition could necessitate replacement of this roof cover. Therefore, it is recommended that a professional roofer prior to closing evaluate the roof cover.

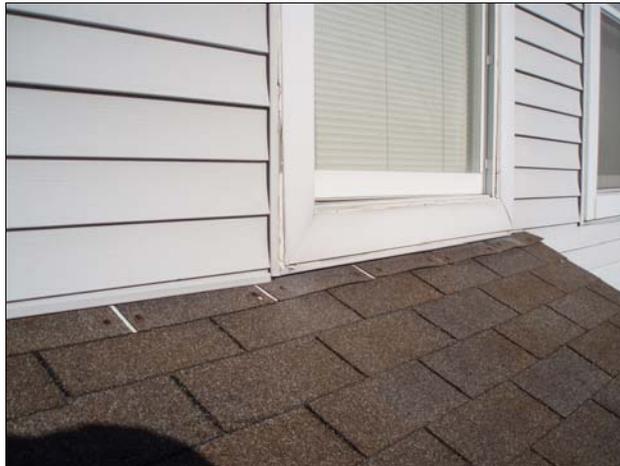
REPAIR NEEDED: The top course of shingles have exposed nails where the original roofing contractor secured the aluminum flashing. The nails to the top course are exposed to the elements. This condition allows rain water to migrate to the sheathing at every exposed nail. Recommendation: Repair as appropriate by a licensed roofing contractor.

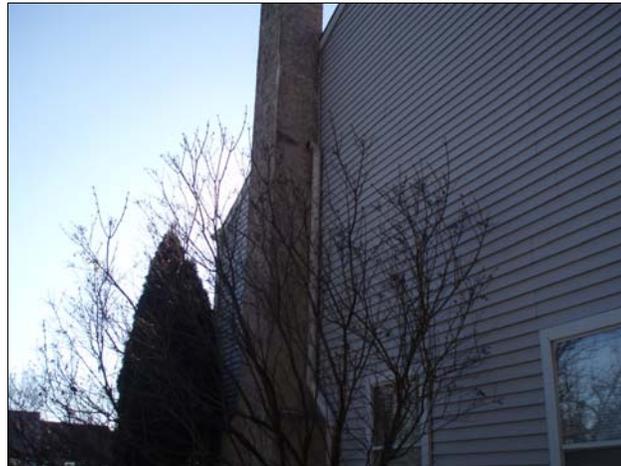
REPAIR NEEDED: The radon mitigation system is improperly vented. According to the RMS (Radon Mitigation Standards) all radon vents are to vent above the roof line. Currently the radon vent ends in a 90 degree turn approx 6 feet below the roof line.

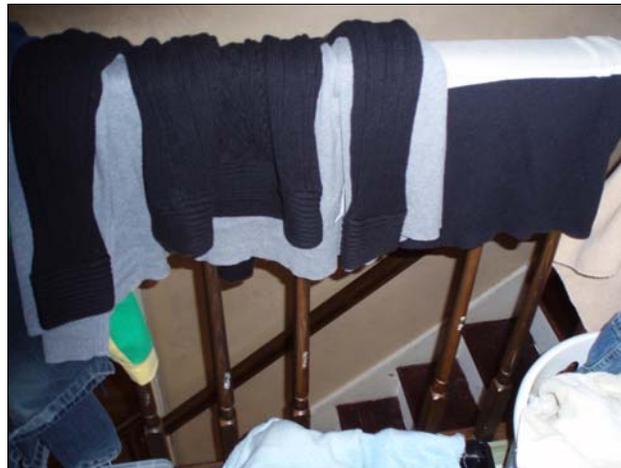
REPAIR NEEDED: Several spindles are missing from the second floor landing railing. It is recommended that these be replaced to prevent someone from accidentally slipping through.

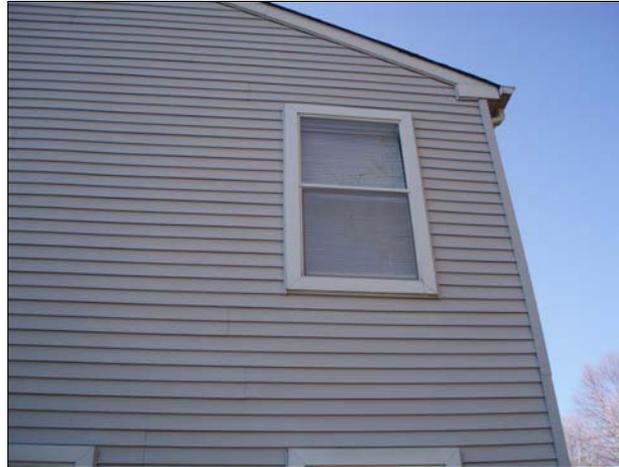
REPAIR NEEDED: There is a damaged screen located in the second floor rear bedroom (your son's bedroom) and should be replaced.

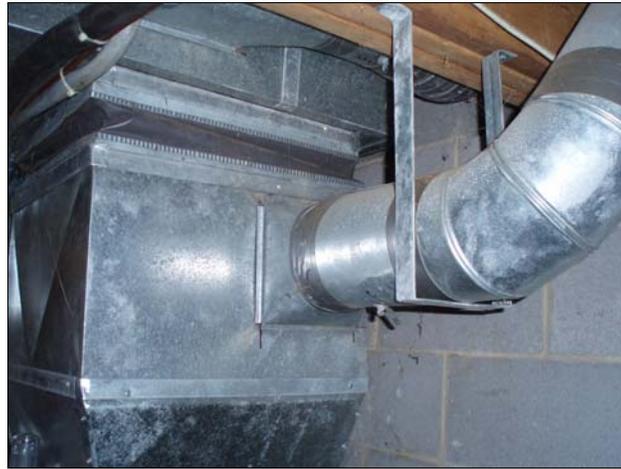
REPAIR NEEDED: Several supply duct connections are not sealed properly and could leak air when the system is active causing a decrease in the efficiency of the unit. It is recommended that these areas be sealed properly using ducting tape.

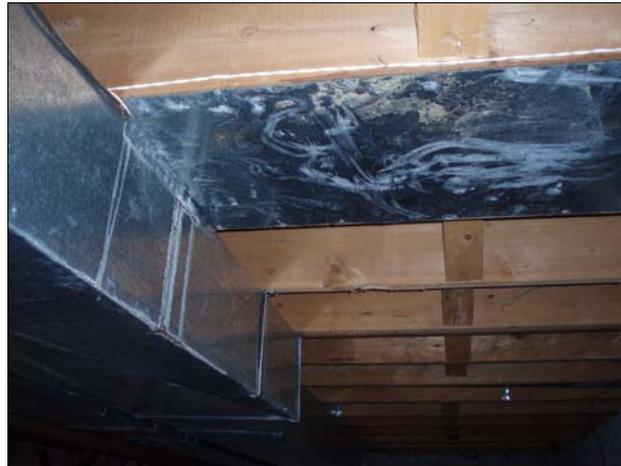
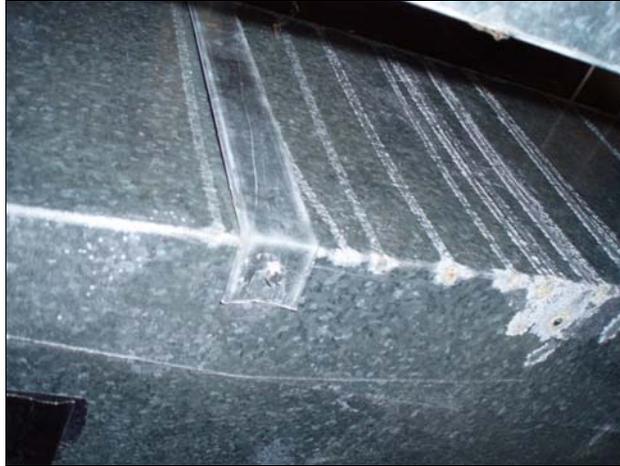
REPAIR NEEDED: Several ducts had noticeable discoloration from either condensation or water infiltration into the duct. While some discoloration is normal there were areas that this was excessive. If water is allowed to stand inside the duct, dangerous mold could begin to grow and through normal use of the system, spread throughout the entire house. These areas in the basement should be opened up and inspected by a certified HVAC contractor, cleaned and repaired or replaced as necessary.

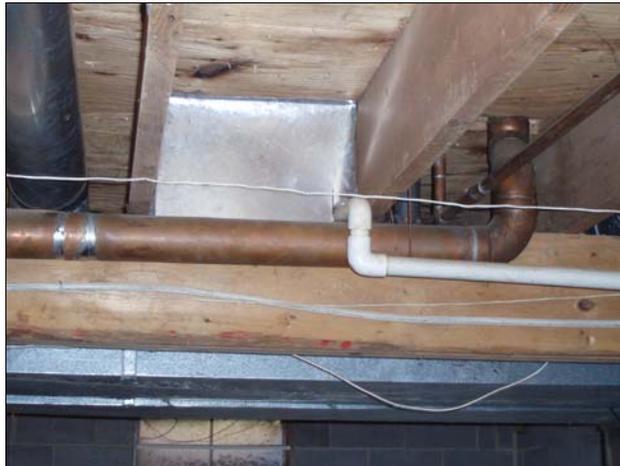
REPAIR NEEDED: A PVC pipe was found extending out of a supply duct and ending next to the furnace. There should be no piping within the ducting of an HVAC system. It is recommended that a certified HVAC contractor review this condition, remove the pipe and seal the duct properly.

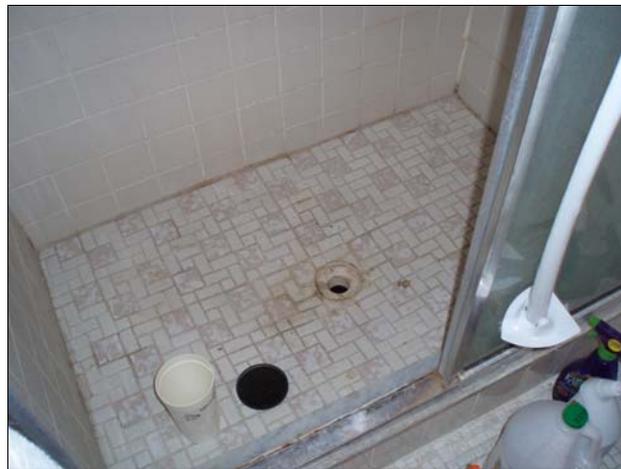
REPAIR NEEDED: The existing shower drain in the master bathroom does not appear to working properly. When inspected water was still sitting within the drain extension and the shower clearly had not been used for some time. The home owner noted that this is not common and often times the drain will back up. The home owner also noted several instances of leakage appearing in the ceiling and walls below this bathroom. It is recommended that certified plumber or Roto Router come out to inspect the drain lines with a camera to determine if there is a blockage within the system causing this problem. The make all necessary repairs to the system.

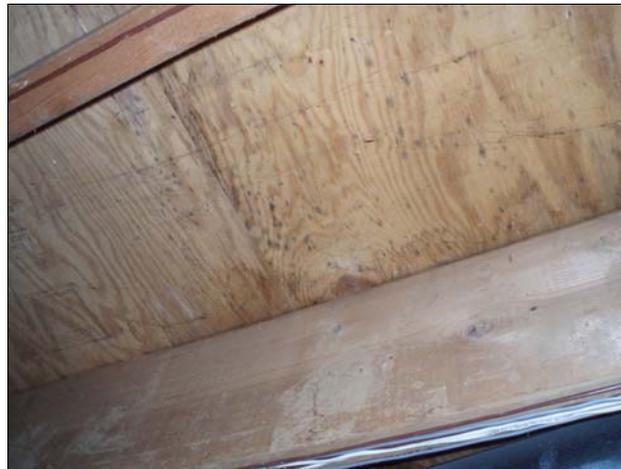
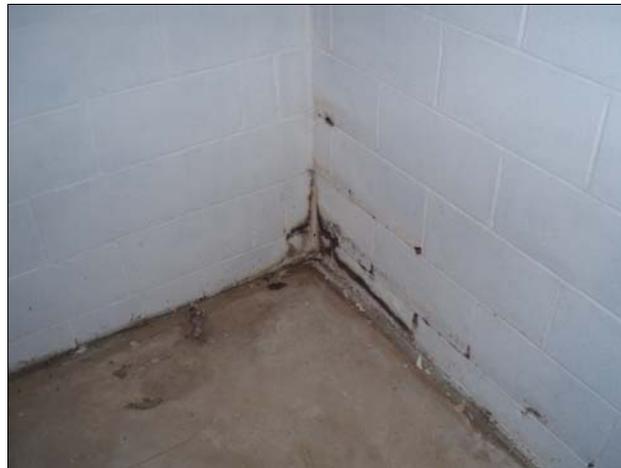
REPAIR NEEDED: What appears to be mold or mildew is coating the surface of some of the under floor components in the basement. Mold needs moisture to thrive. The use of dehumidifier could help to eliminate this problem. Clean the affected areas with a solution of bleach and warm water.

If this problem returns I recommend have a mold analysis performed to determine the need for remediation.

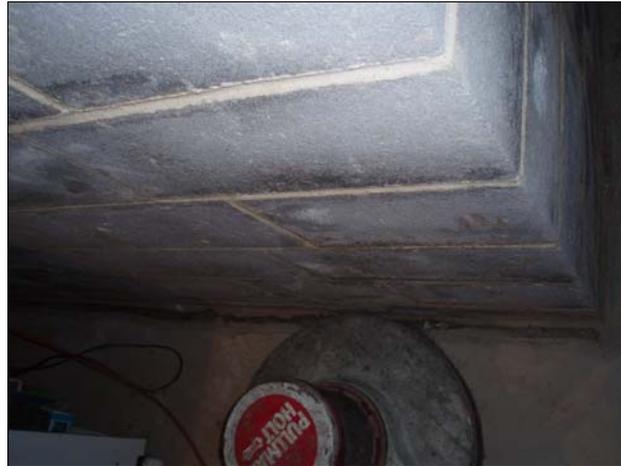
ATTENTION: Efflorescence or other clues to moisture infiltration seen at the basement walls indicates a lack of adequate damp proofing at the exterior of the foundation. This will raise ambient moisture levels in the basement and could result in excessively humid conditions, leading to formation of mold or conditions conducive to wood-destroying organisms. Some measures should be taken to either reduce humidity or reduce the amount of moisture passing through these basement walls. There are heavy coating products that can be applied to the inside surfaces of the foundation to block water movement, interior drainage systems can be installed and/or dehumidifiers can be used. Consultation

with a reputable drainage/dampproofing contractor to discuss options and related cost is recommended.

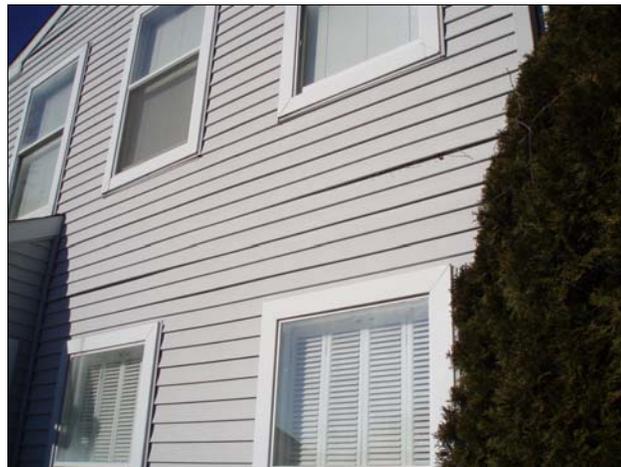
REPAIR NEEDED: The vinyl siding is damaged at the front facade below the second story windows and at the privacy wall located across from the front door. Besides being unsightly this can allow unwanted moisture penetration into the exterior envelope and wall cavity. Repair requires removal and replacement of the affected panels by a professional siding installer.

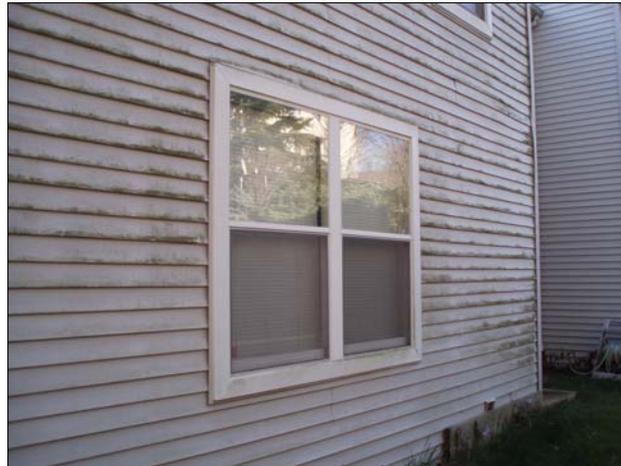
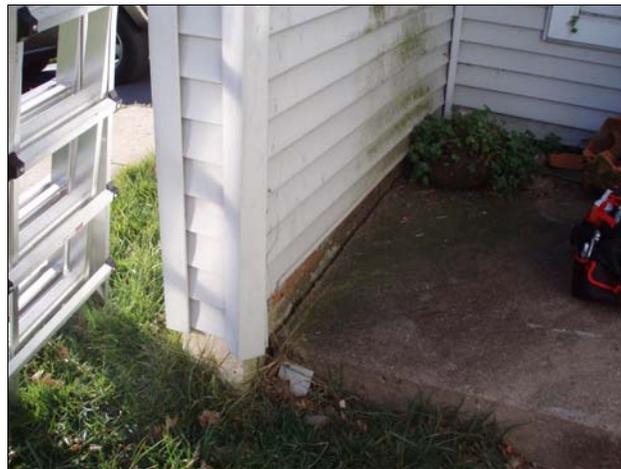
ATTENTION: The vinyl siding is mildewed at the front and rear facades. According to the Vinyl Siding Institute (<http://www.vinylsiding.org>), mildew can be removed by wiping down the siding with a solution made up of 1/3-cup powdered laundry detergent (e.g., Fab©, Tide©, or equivalent), 2/3-cup powdered household cleaner (e.g., Soilax©, Spic & Span©, or equivalent), 1 quart liquid laundry bleach and one gallon of water. One should begin at the bottom of the siding and work upward to avoid streaks and then rinse with clear water. Care should be taken not to use any detergents containing ammonia with this solution and to wear safety goggles and protective clothing.

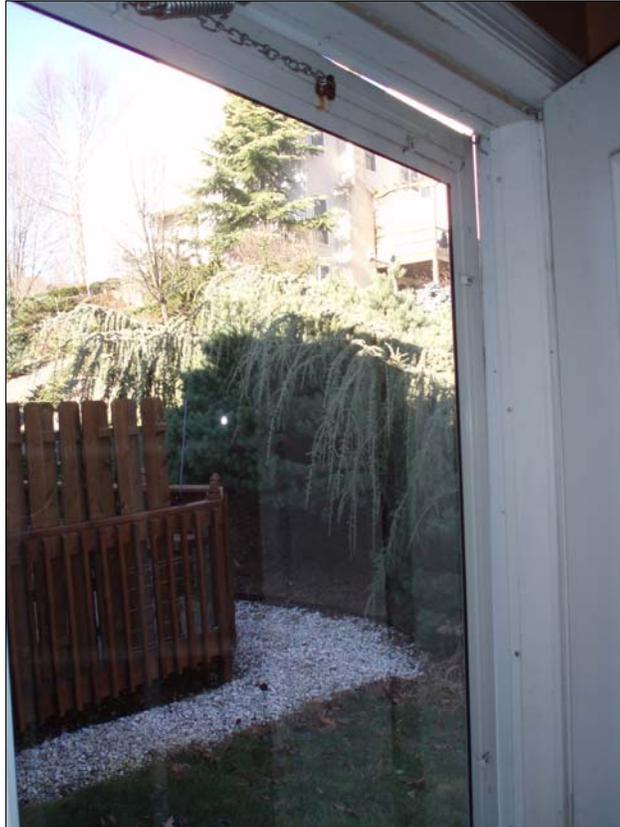
REPAIR NEEDED: The storm door at the rear entrance is misaligned and no longer closes properly. It is recommended that this door be repaired by a competent carpenter.

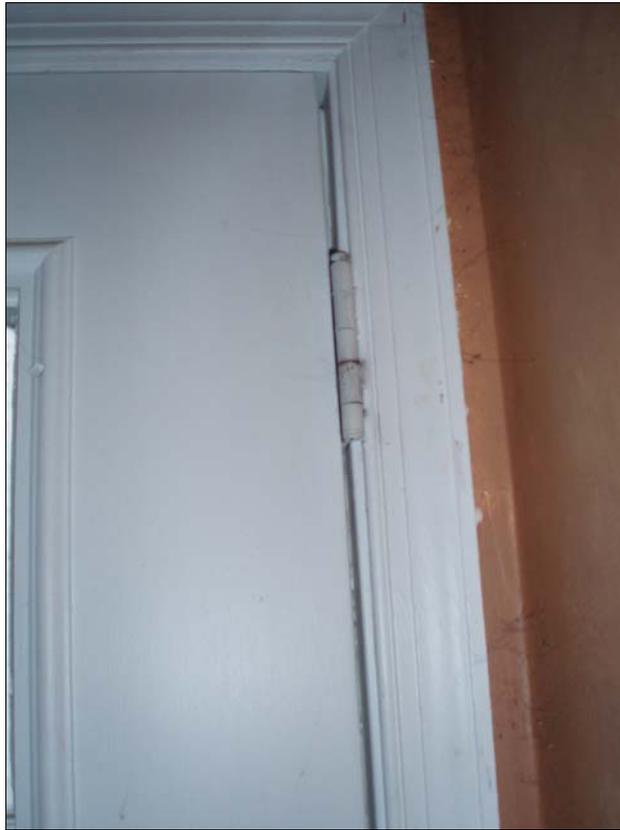
REPAIR NEEDED: The main door at the rear entrance is binding in its frame is difficult to open. It appears that the door is beginning to delaminate causing the hinges to be pulled away from the frame near the top of the door. It is recommended that this door be replaced and new hinges installed.

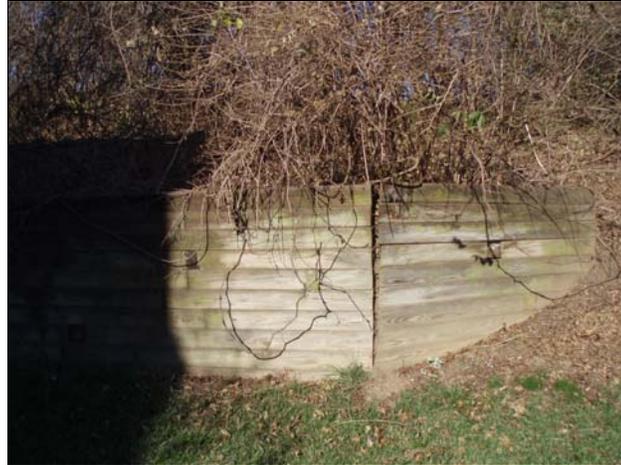
REPAIR NEEDED: The retaining wall is unstable due to poor construction that is causing the wall to move. This may be the result of a wall without the requisite drainage or retention measures installed behind it to keep it firmly in place. I recommend further evaluation and correction as necessary by a professional contractor.

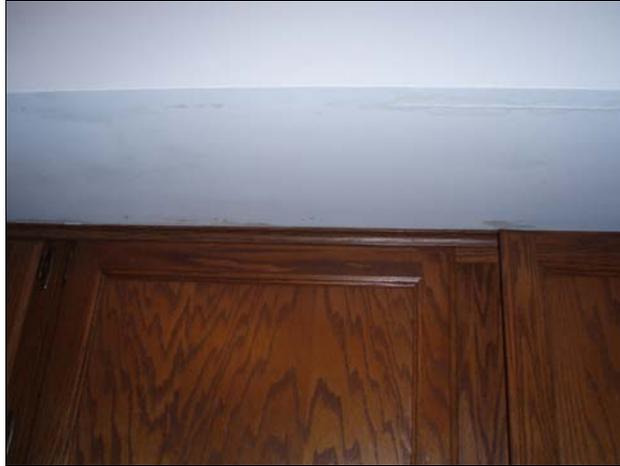
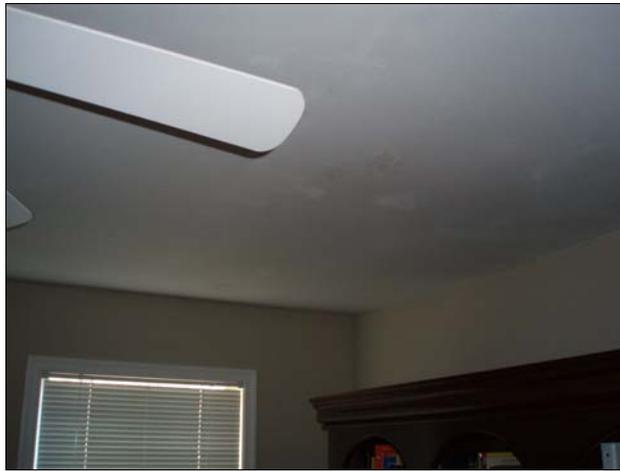
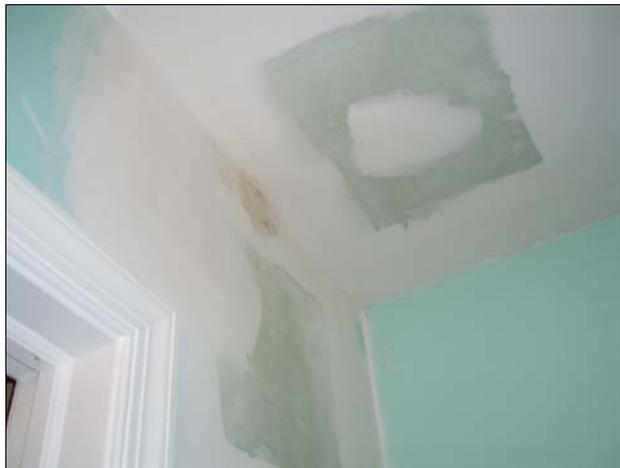
I noted signs of previous plumbing leaks (water-damaged floors, cabinet bottoms, stains at walls, etc.) that may be indicative of recent repairs to the system. If this hadn't been previously disclosed, I recommend the client determine from the homeowner exactly what those repairs had been.

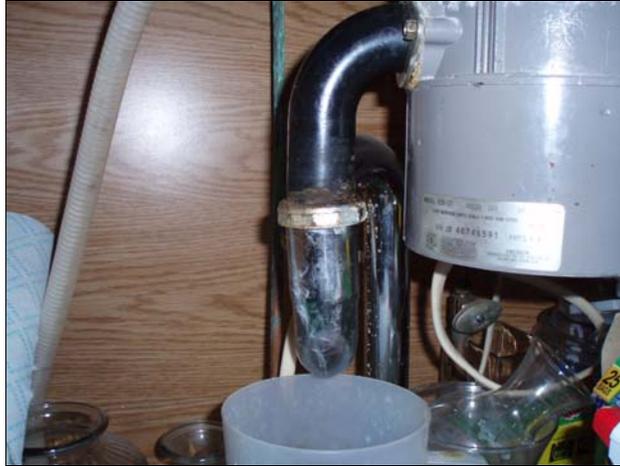
REPAIR NEEDED: The drain under the kitchen sink exhibits an active leak. Recommendation: Repair as appropriate.

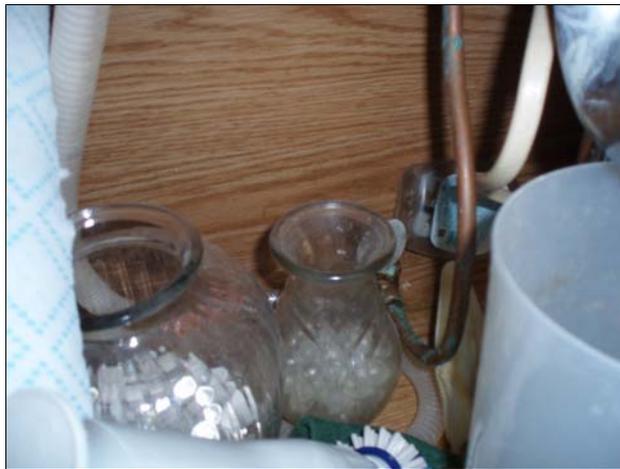
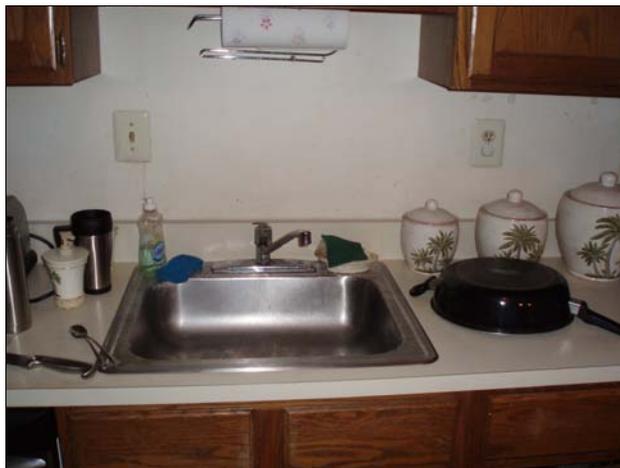
REPAIR NEEDED: The kitchen sink exhibited very low pressure when tested and the faucet housing was damaged and visibly leaking when turned on. I recommend that this unit be replaced and the water lines below be changed to a standard 3/8" flexible line to help increase the water pressure at this sink.

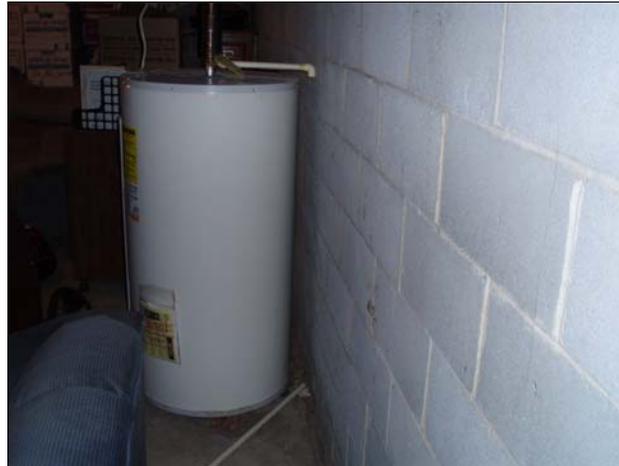
REPAIR NEEDED: The TPR drain extension has fallen off and needs to be replaced. The drain should discharge no more than 6" above the ground.

The reason for the discharge pipe is simple - to prevent injury from scalding, should the TPR valve suddenly vent boiling water or water under extreme pressure.

TPR drain lines are prohibited from having threading at the bottom where discharge occurs.

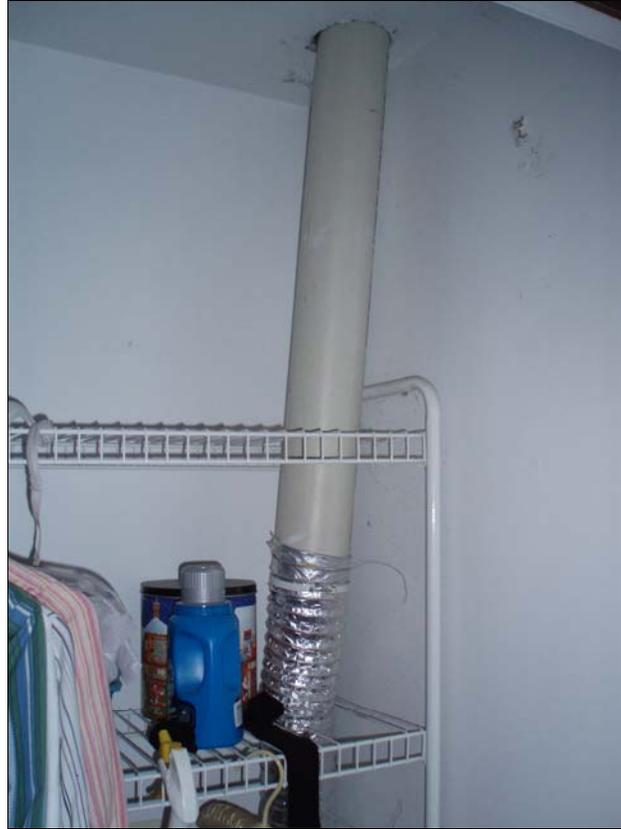
REPAIR NEEDED: The existing dryer vent is a combination of flexible metal ducting, PVC piping and flexible plastic ducting which vents through the attic and out the side wall of the residence. The current ducting is not a safe setup and is potentially a fire hazard. This needs to be replaced with all new flexible metal ducting from the dryer to the exterior vent in the attic wall.
